Safety Inspection Report

Annual Inspection

Rackenford Common

03 March 2025

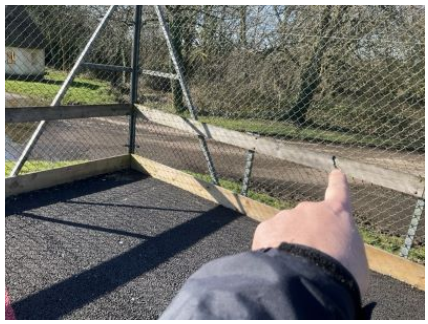
Timber is smashed.

Timber rail damaged.

Replace.
